Document Ref: CHC2026-0002AD | Rev 1

## RE: LOT 432 GEOTECHNICAL REPORT EARLSBROOK SUBDIVISION STAGE 2, LINCOLN

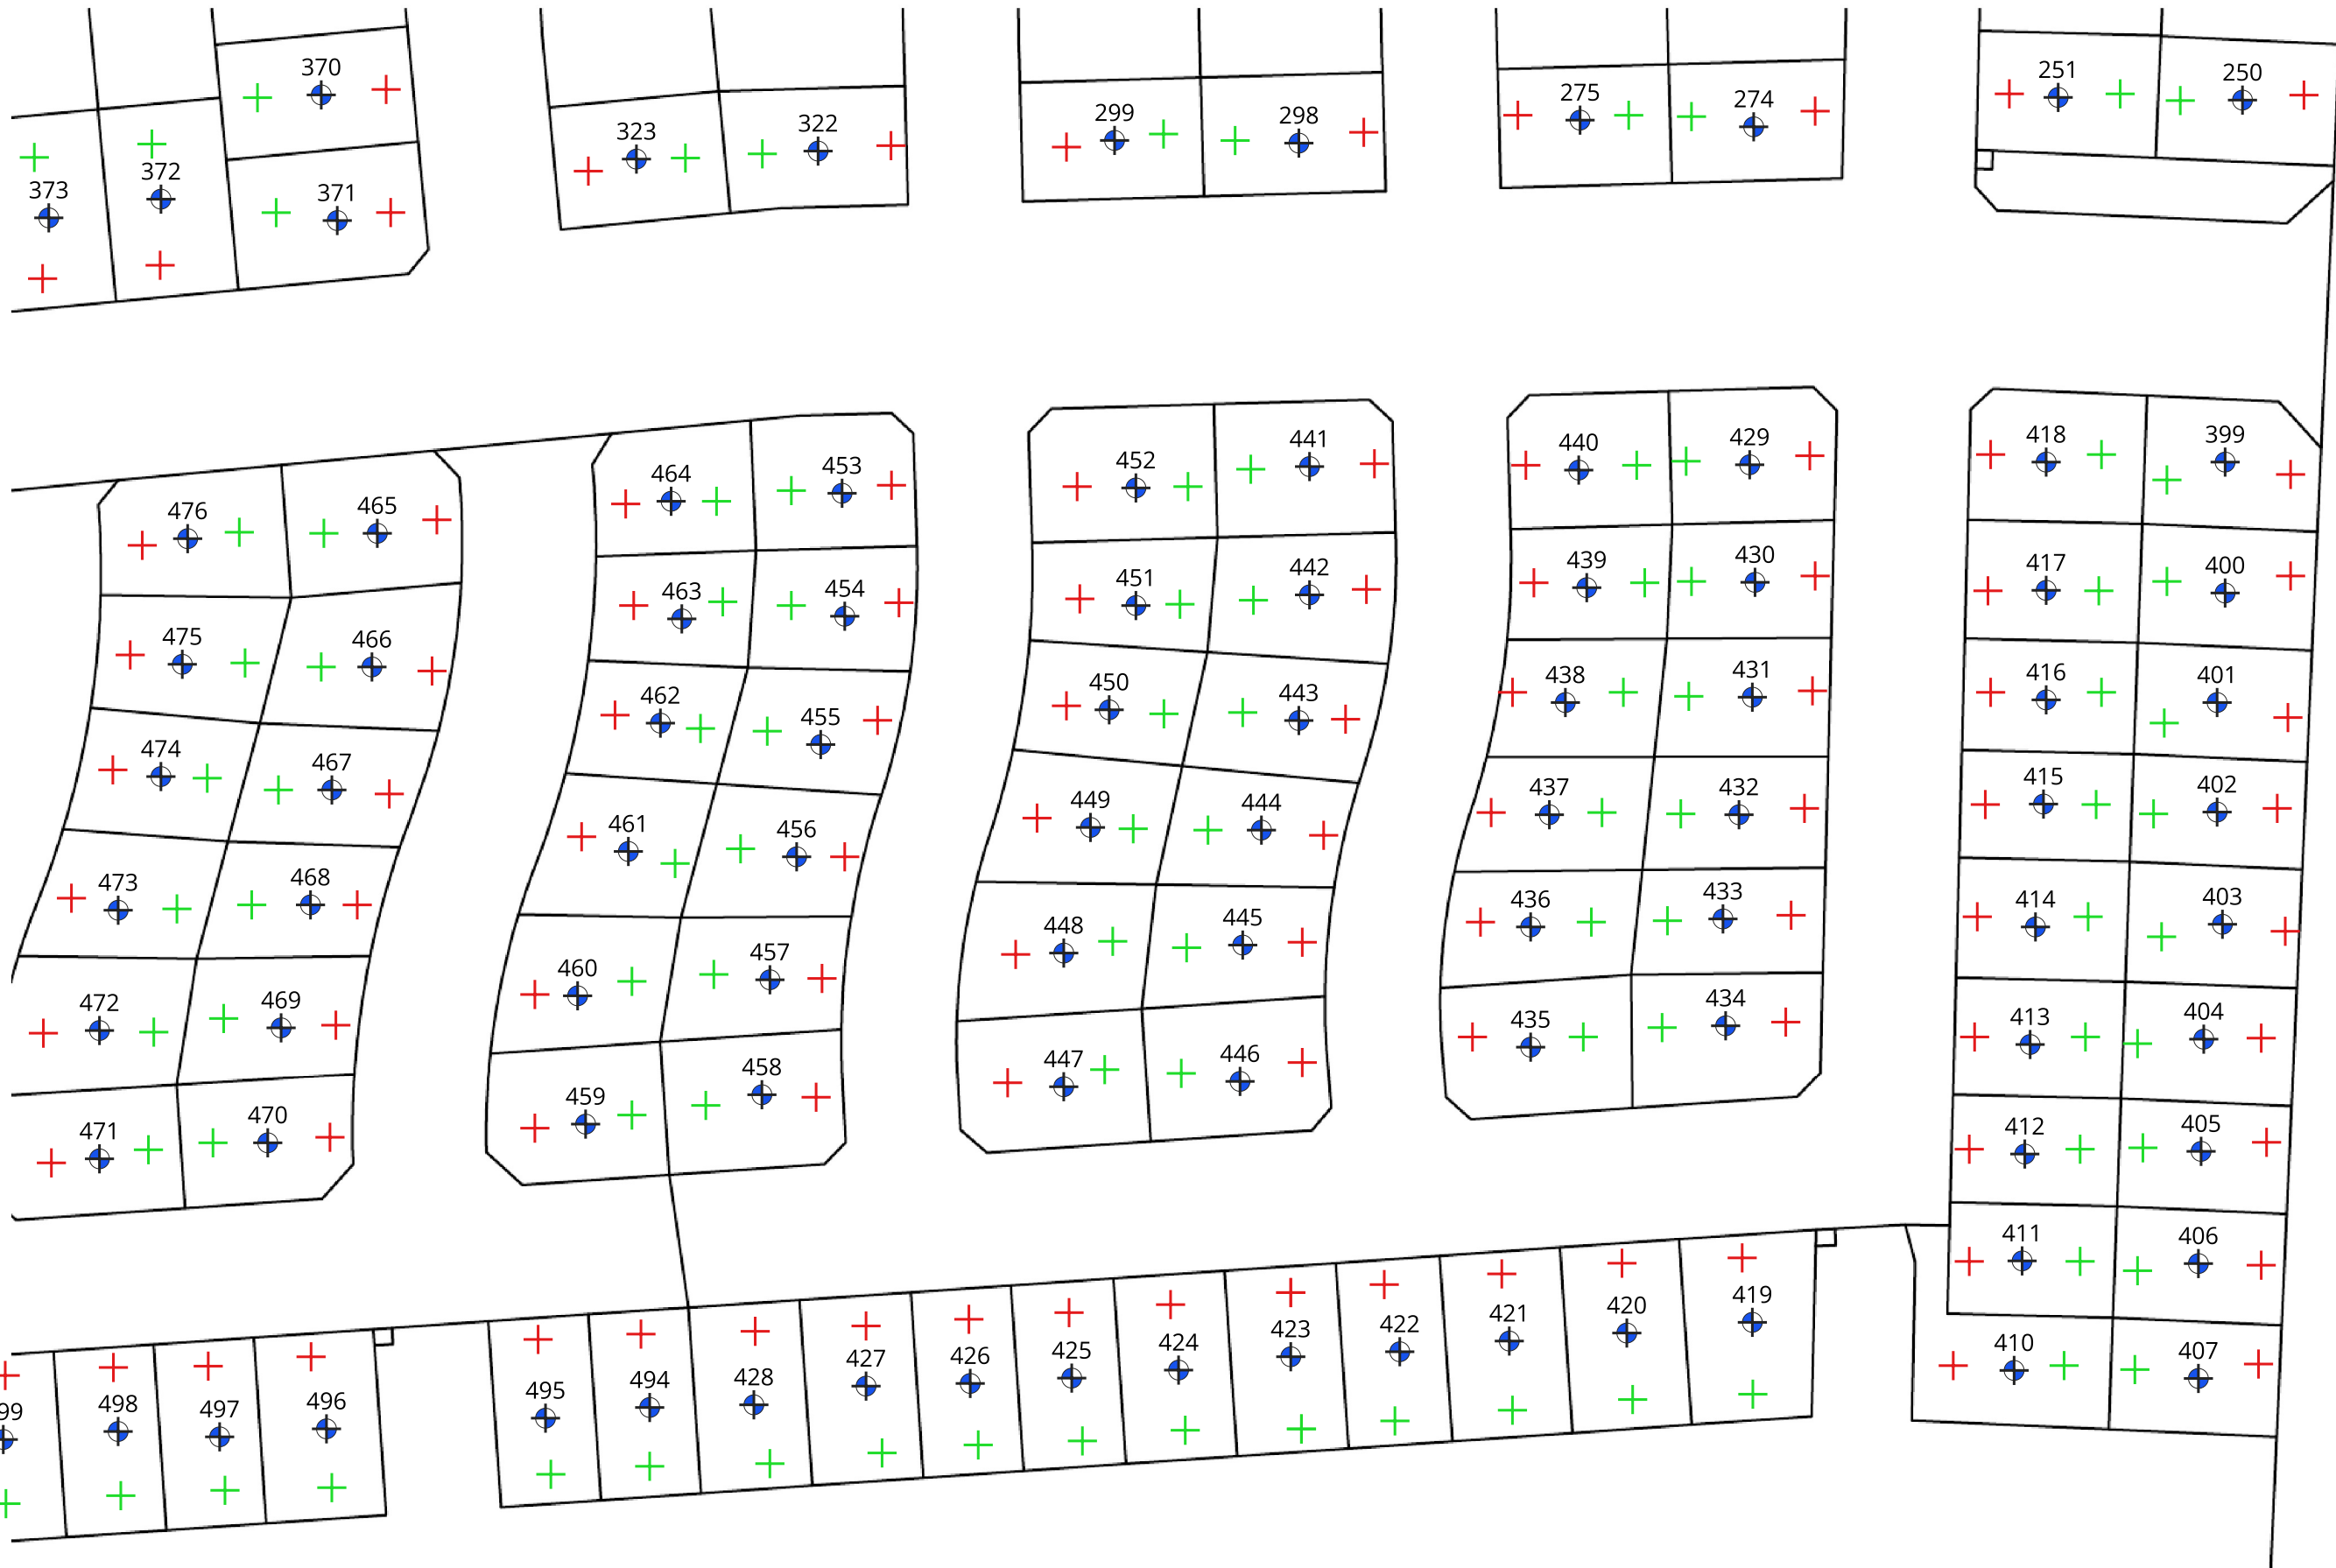
| | TITLE:<br><b>LSGR Investigation Plan</b> | REVISION:<br>0 | SCALE:<br>NTS |

| Item | Comment |
|---|---|
| Site Investigation | CMW completed 1 hand augered borehole (HA) within the lot to a maximum depth of 0.5mbgl, and 2 dynamic cone penetrometer tests (DCPs) to a maximum depth of 0.9mbgl. These investigation locations are shown within the attached plan. |
