25 June 2026

Document Ref: CHC2026-0002AD | Rev 0

## RE: LOT 510 GEOTECHNICAL REPORT EARLSBROOK SUBDIVISION STAGE 2, LINCOLN

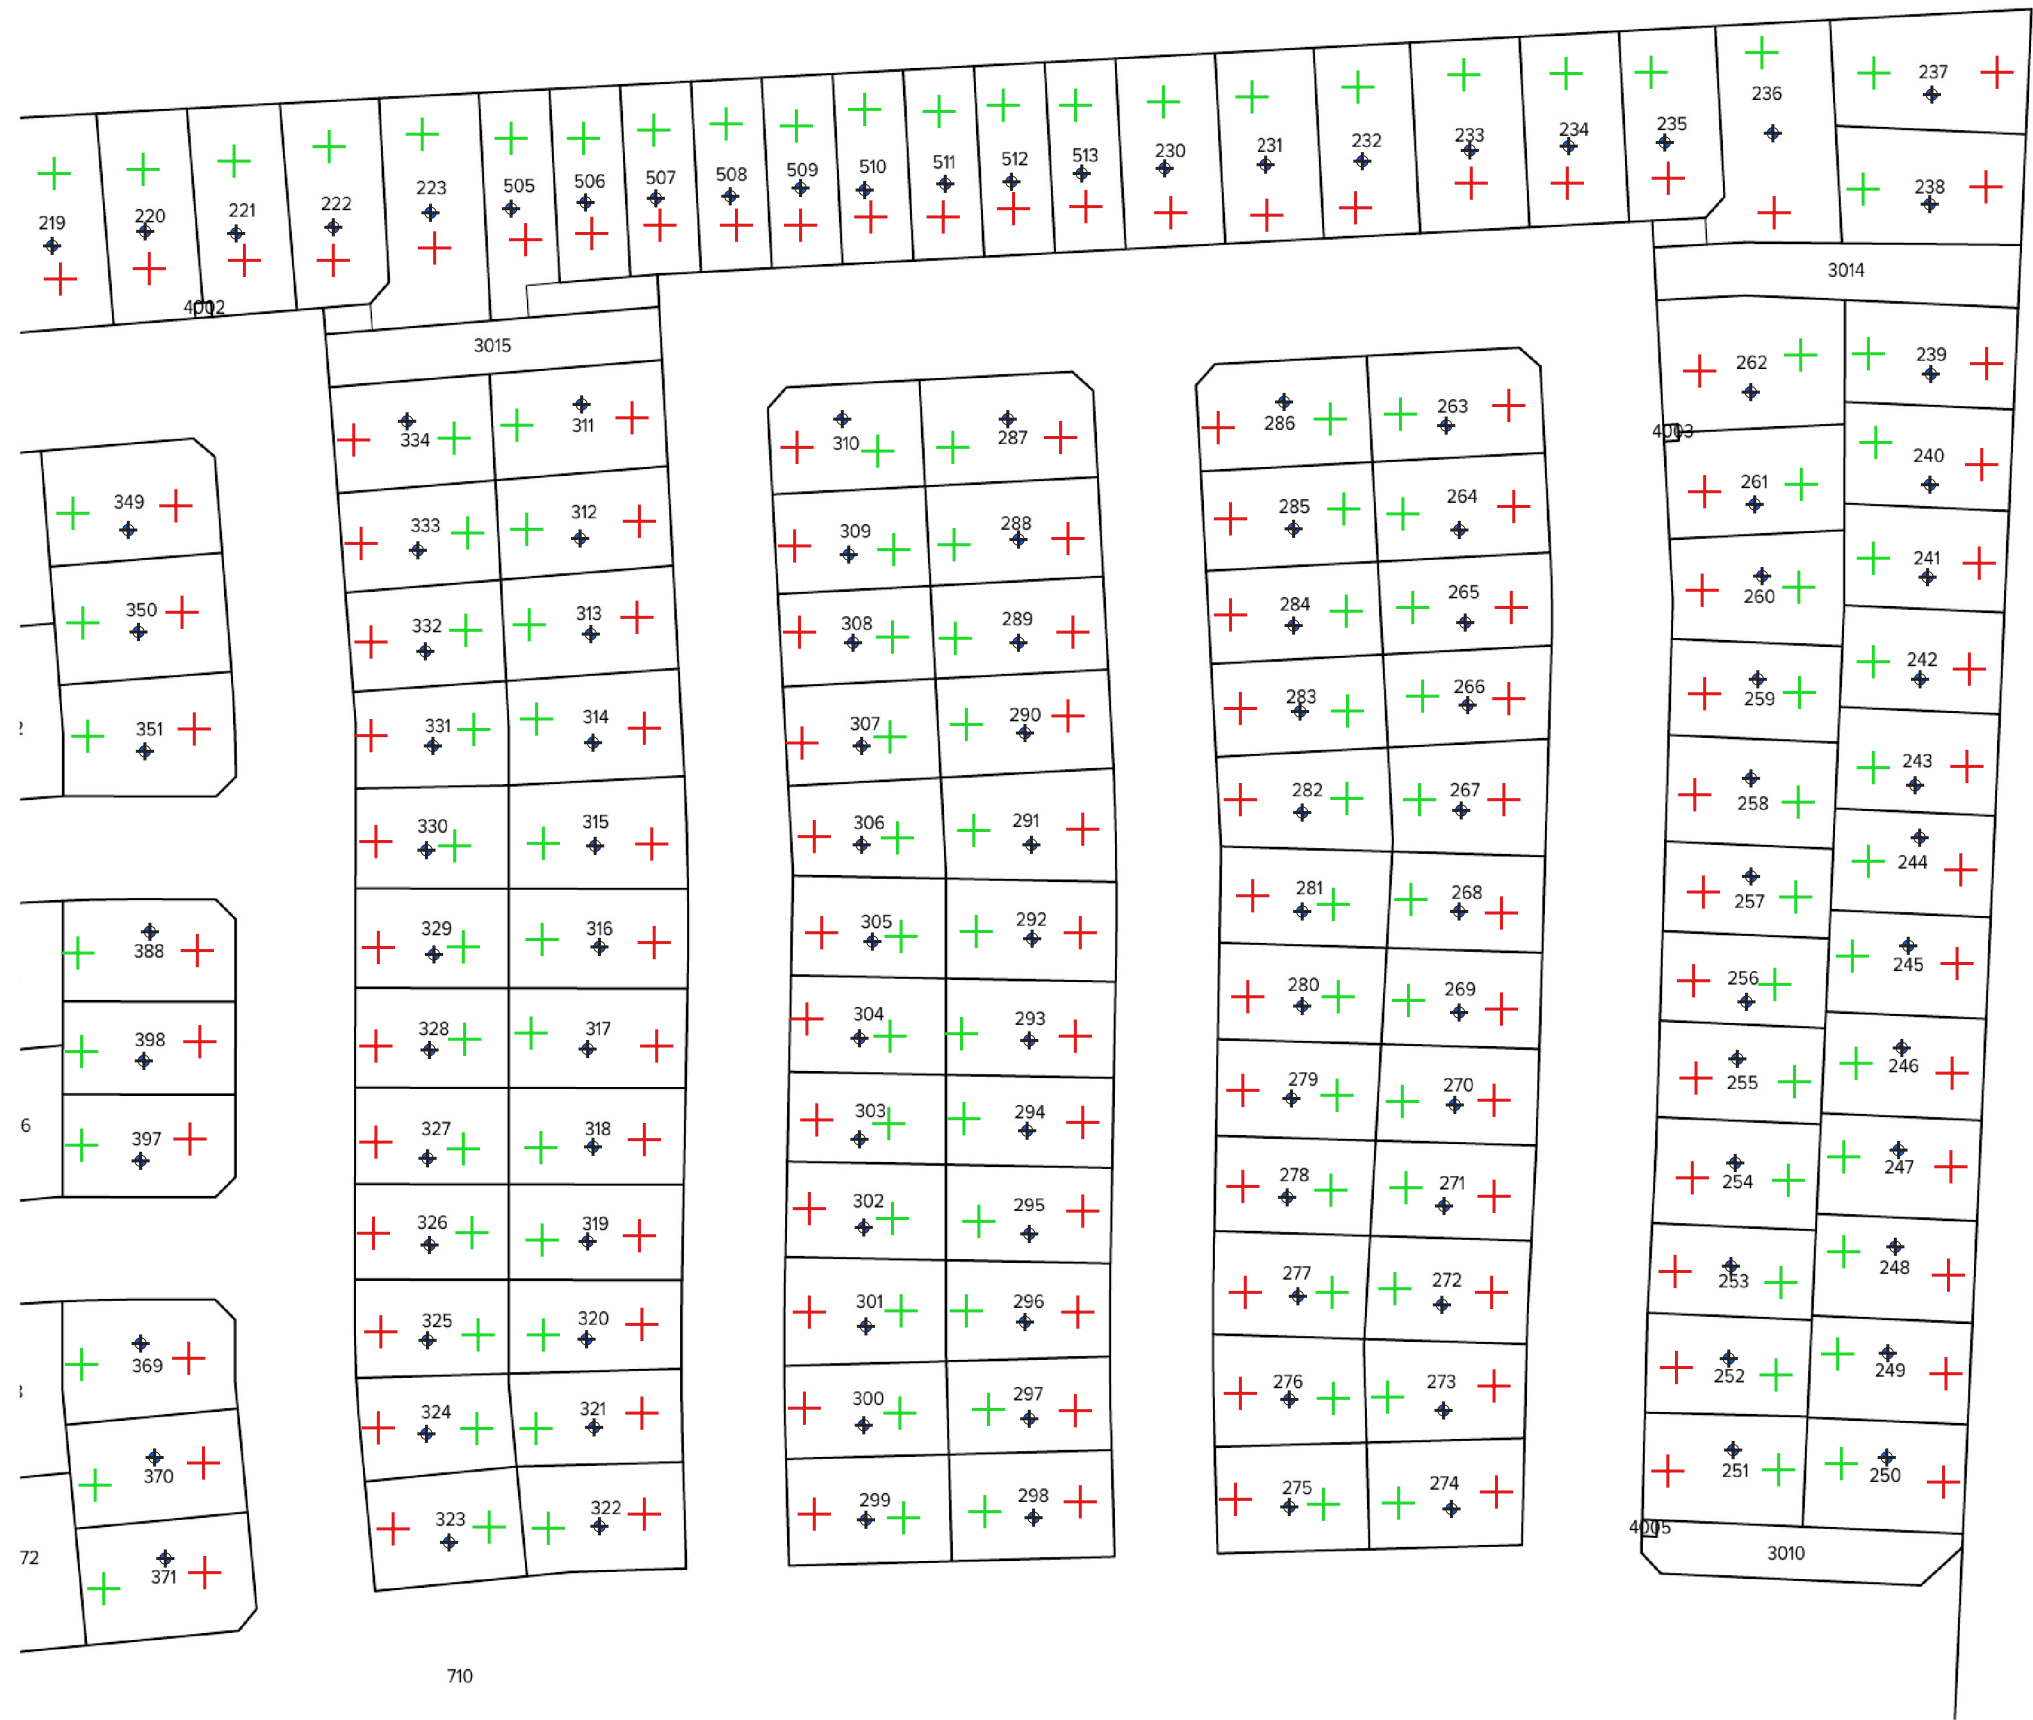
| | TITLE:<br><b>LSGR Investigation Plan</b> | REVISION:<br>0 | SCALE:<br>NTS |

| Item | Comment |
|---|---|
| Site Investigation | CMW completed 1 hand augered borehole (HA) within the lot to a maximum depth of 0.7mbgl, and 2 dynamic cone penetrometer tests (DCPs) to a maximum depth of 1mbgl. These investigation locations are shown within the attached plan. |
