Document Ref: CHC2026-0002AD | Rev A

## RE: LOT 508 GEOTECHNICAL REPORT EARLSBROOK SUBDIVISION STAGE 2, LINCOLN

The purpose of this report is to provide foundation options and recommendations for residential development on Lot 508. This report can be included within an application for residential building consent.

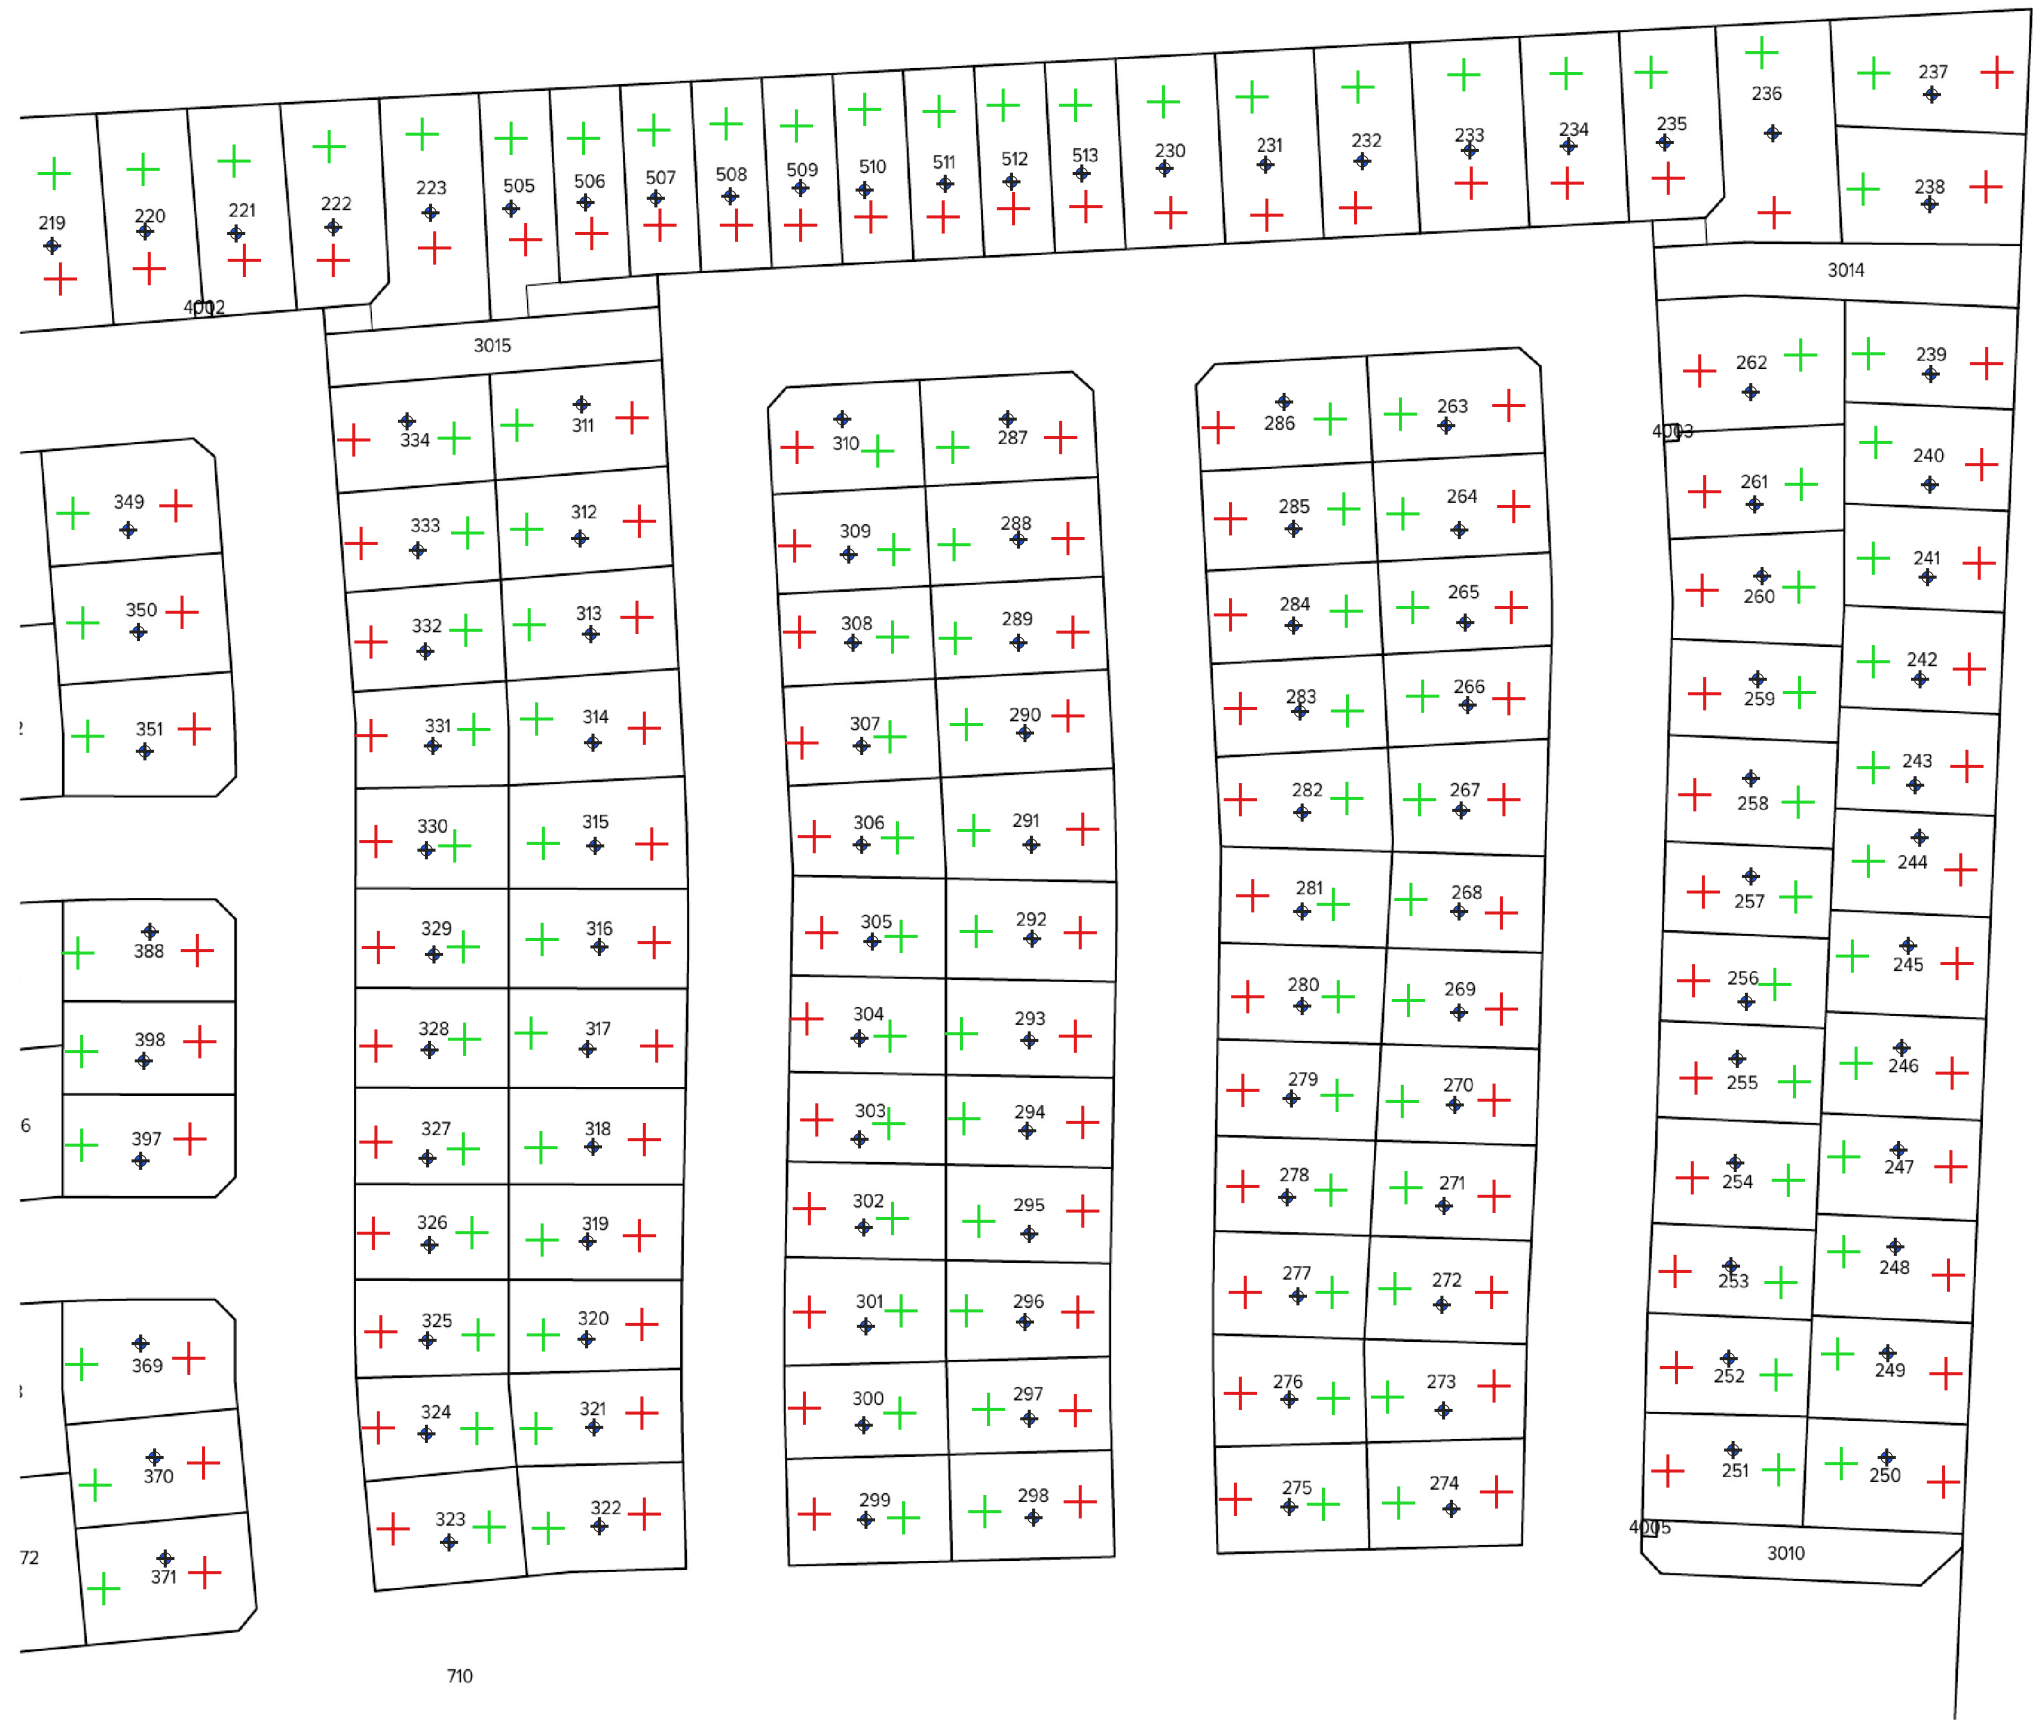
**LEGEND:**  
Test Locations  
+ DCP1  
+ DCP2  
• HAND AUGER TEST LOCATION

**NOTES:**  
1. Hand Auger locations are approximately at center of the lot.  
2. Map not to scale

Attachments: Geotechnical Investigation Plan  
Hand Auger logs
